Using infrared cameras in building defect litigation

Testing Functions Case Study

Measuring tools: Fluke TIR2-FT Thermal Imager

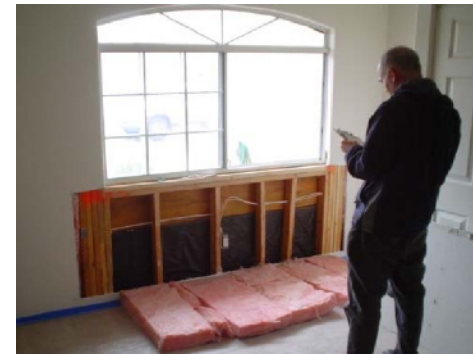
Expert performing ASTM window test.

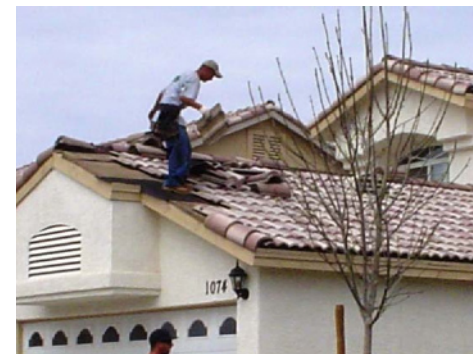
Expert performing testing on residential roofs.

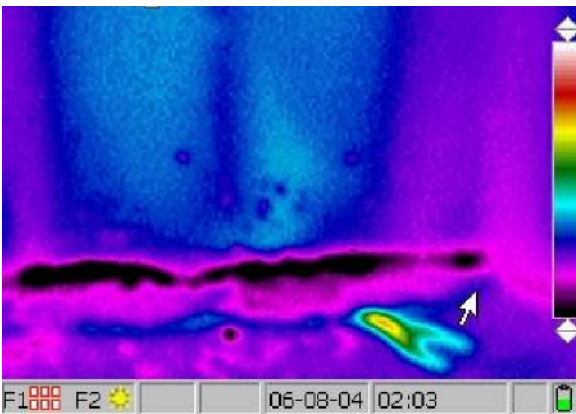
Using a moisture meter to confirm water at the bottom of a wall after taking a thermal image.

- cutting the wall open to confirm the pinpointed location
- use a moisture meter to confirm the presence of water
- using a borescope (penetrate with a small camera) and photo document the interior of the wall.

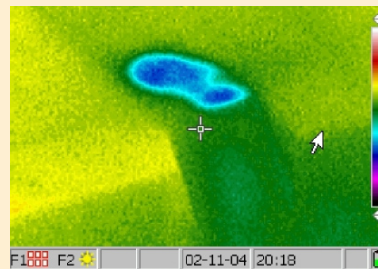
Plumbing leak anomaly found during visual inspections.

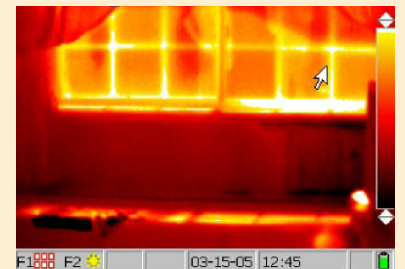
Water intrusion at a window test.

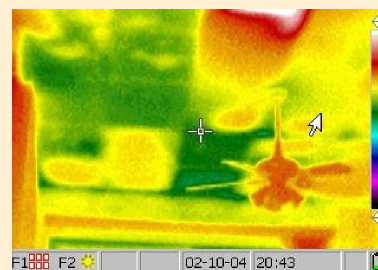
Missing insulation.

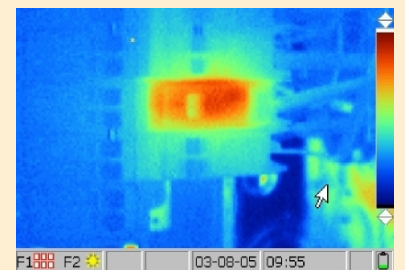
Electrical panel circuit anomaly. It may not be a problem but should be inspected by an expert. Working with live electricity requires an electrician to open and remove panel covers.

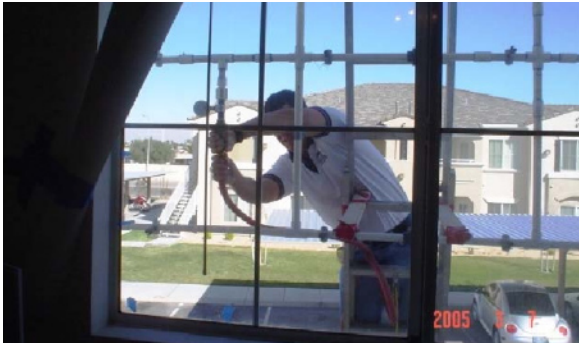
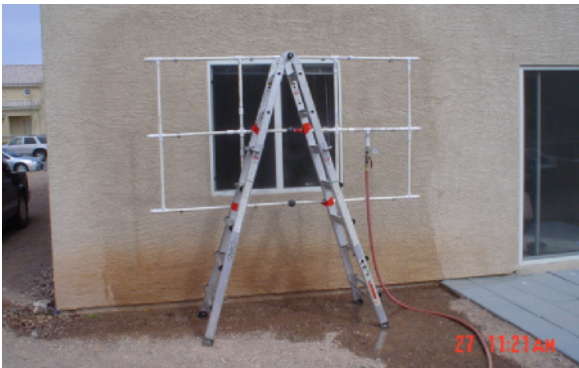
Calibrated spray rack used to simulate a rainshower.

Testing is not necessarily done conveniently after rain showers or turbulent weather, so the tests are designed to simulate specific rain patterns, wind storms, and so on. Specific equipment is necessary to scientifically test the possible failures. Calibrated spray racks can simulate a rainstorm or a blower door test can simulate negative/positive air pressure on the doors and windows.

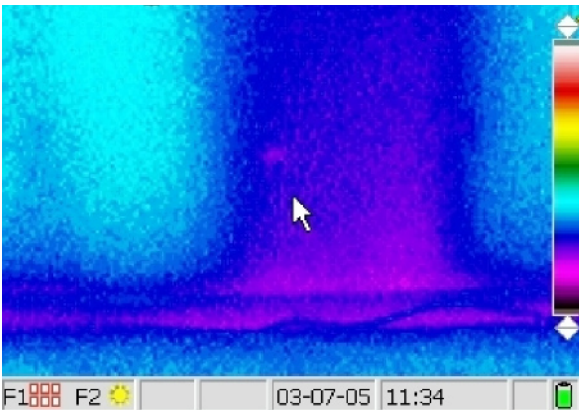
Thermal signature after 15 minutes of ASTM water test.

Water can take longer to detect than the ASTM time-frame used to determine leaks, because the wall has several layers to penetrate before the moisture is thermally apparent. So as long as you stop the application of water within the ASTM time allotment, you can still go back 30 minutes or more later to see if the thermal signature appears. You don't necessarily need the maximum Delta T to see the anomaly. The photos below show a water thermal signature increasing as moisture travels through the inner layers of the wall cavity.

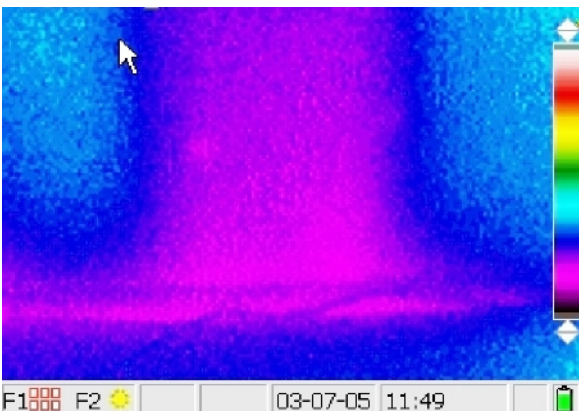
Thermal signature after approximately 30 minutes of ASTM water test.

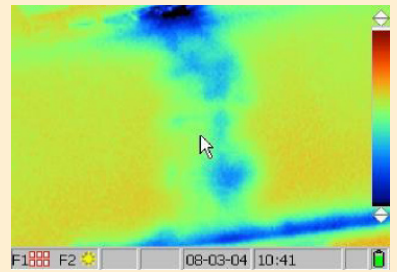
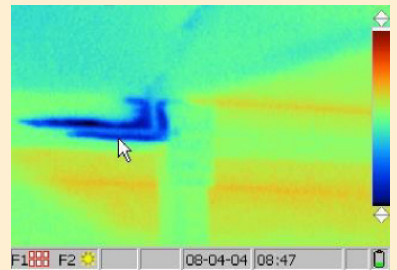
Samples of deck soffits that show water penetration and migration. Because there are usually fewer building components from top to bottom of the soffit, water migrates quickly and leaves a very identifiable trail.
